ARBORICULTURAL DETAILED INSPECTION

Fallow Fields, Compton Street, Compton

Ref: ADI20-1007

Date: Thursday, 06 August 2020

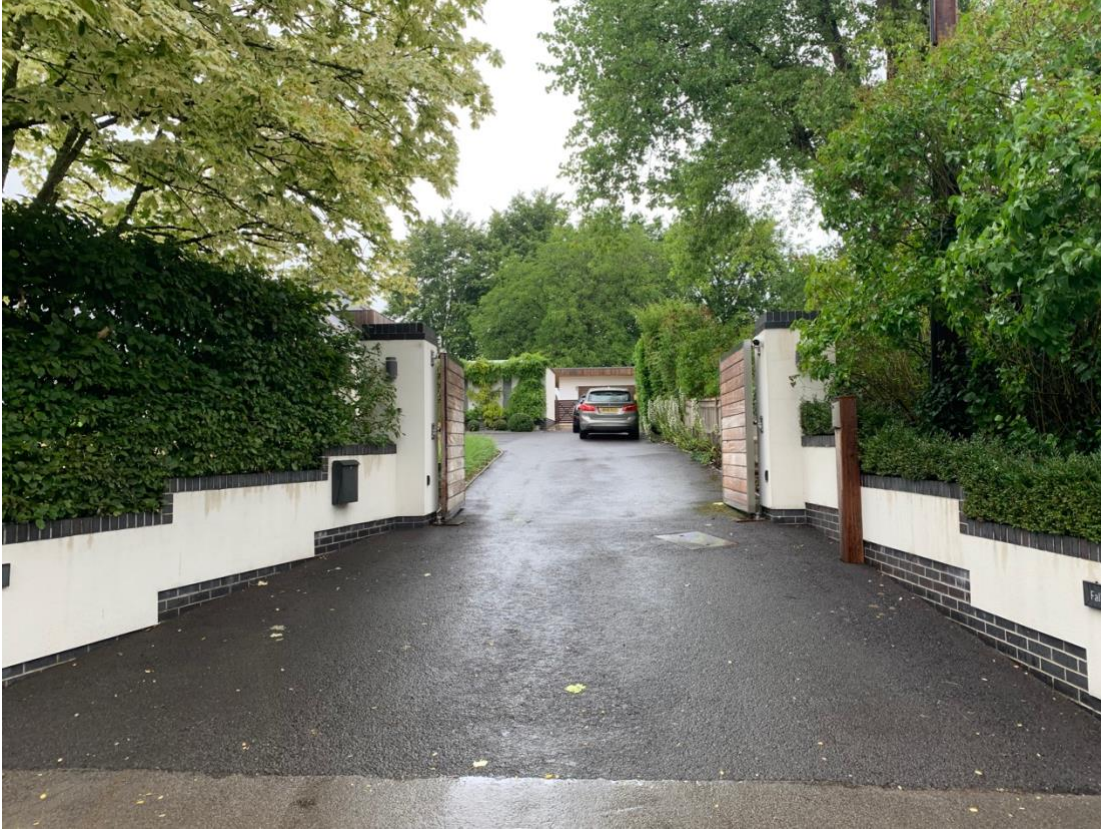
The tree in question is partially visible from Compton Street when viewed from the access to Fallow Fields. When viewed from other locations along Compton Street the tree is not highly visible at all. When viewed from the access to Meadow Cottage, the view is obstructed by vegetation, as it is from Little Pensbury. When viewed from the access to Beaver Lodge, one can just about see the top 1-2m of the crown with the line of beech trees to the rear. When viewed from Attwoods Drove and the agricultural land to the north, the view is completely blocked by the beech trees. Photos showing the views from Compton Street can be found in Appendix 2.

Photo showing view from Fallow Fields entrance

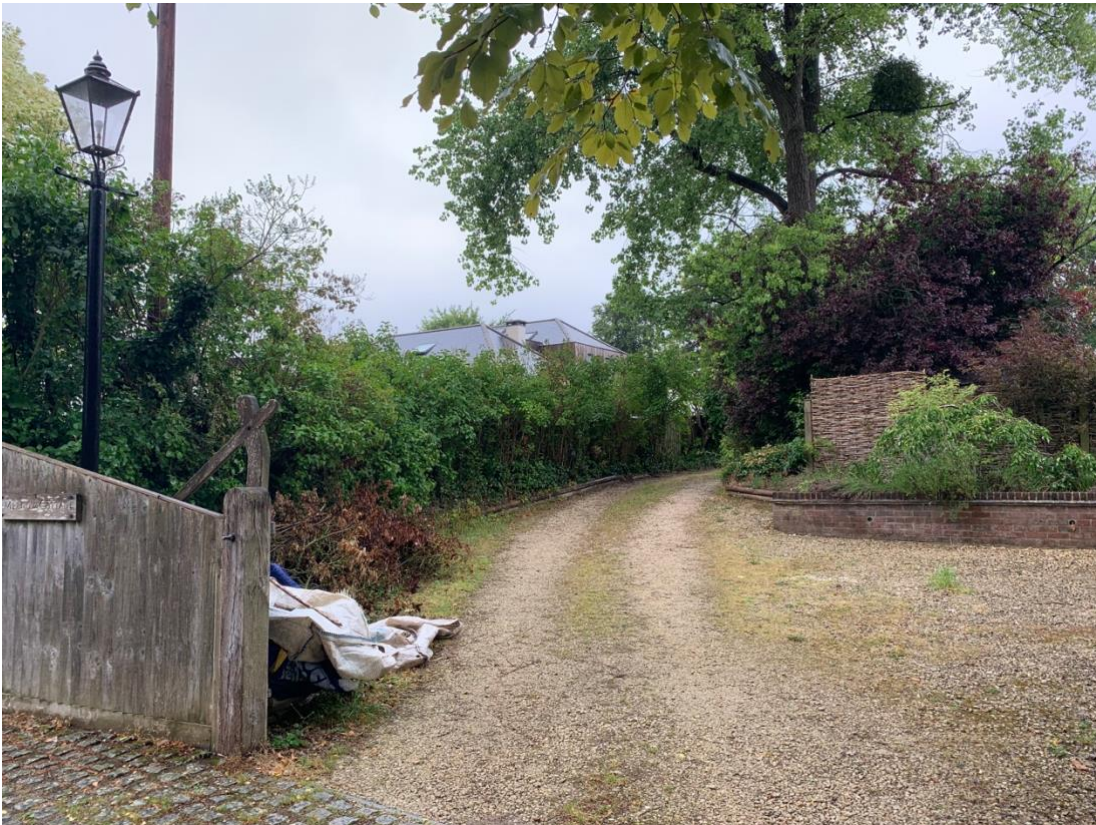
Photo showing view from Meadow Cottage entrance

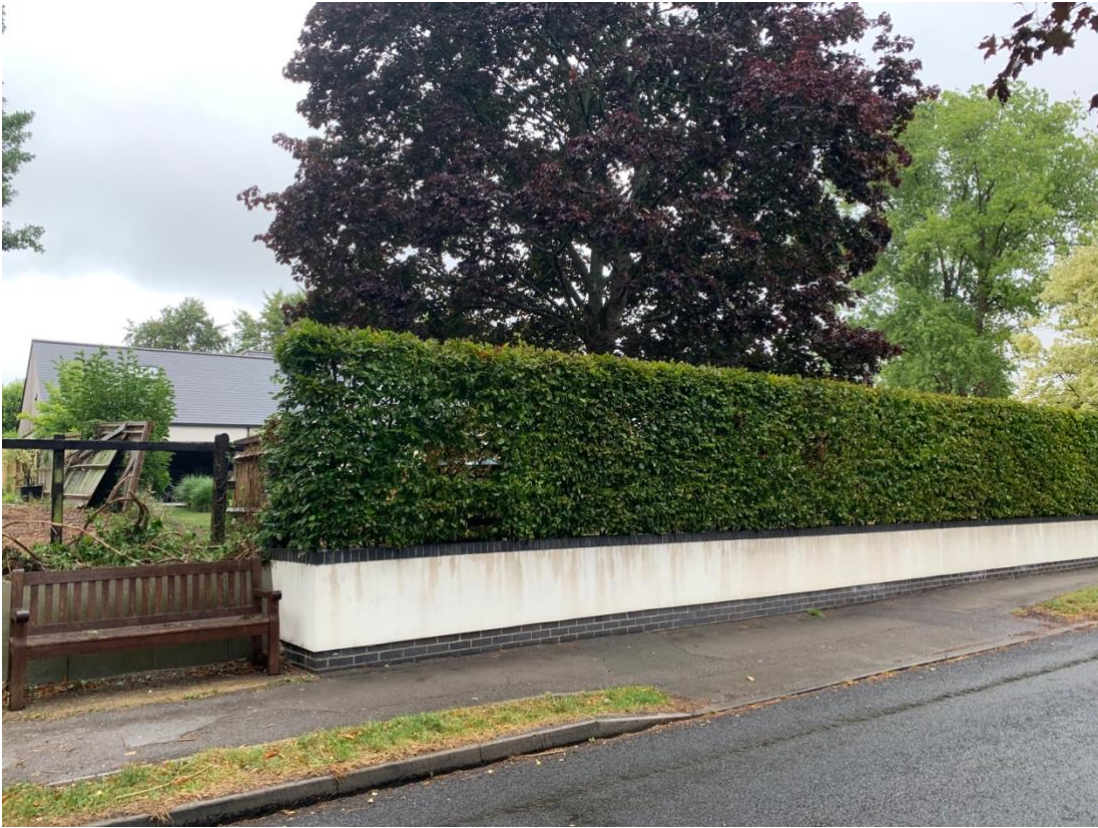
Photo showing view from Little Pensbury entrance

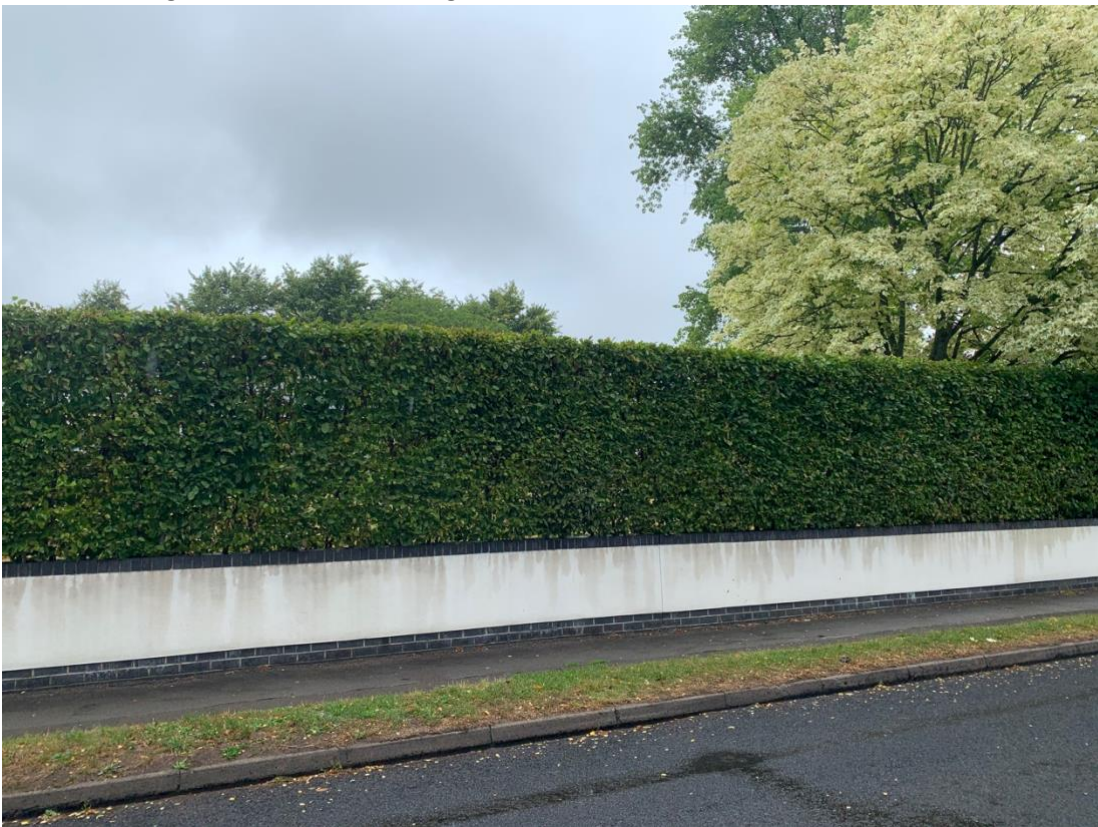
Photo showing view from Beaver Lodge entrance
