Building survey report

Meadowside Leisure Centre, Whiteley, Fareham PO15 7LJ

Prepared for: Winchester City Council
Prepared by: Shaun Miller BSc (Hons) MRICS
Lee Snow BSc (Hons)
Date: 04 October 2019
Reference: 81868/40/SPM/LSS

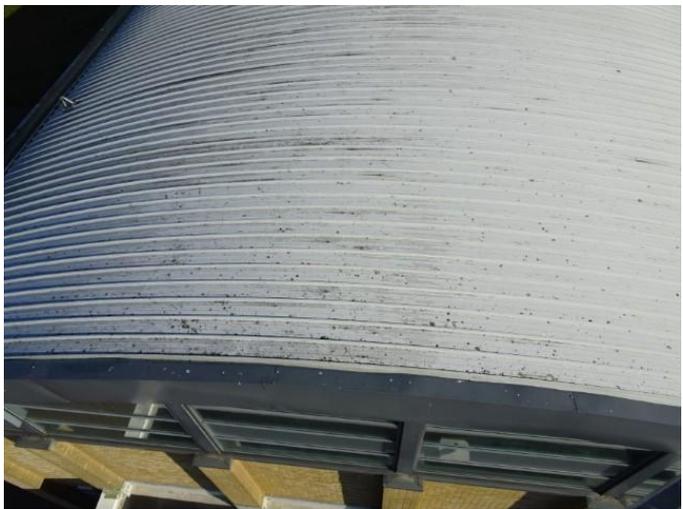
- 2.1.7. The roof is weathertight, with nominal evidence of leaks. The external prefinished coating to the sheets is beginning to fade with some isolated areas peeling back. A minor amount of debris (including footballs), was noted within the gutters. This build up has the potential to clog the outlets and downpipes. The gutters require general clearance at frequent intervals (suggest at least twice a year). In conjunction with the cleaning, we also recommend re-lining of gutters with a liquid system in the long term.

An aerial photograph showing a large, curved, vaulted roof structure made of light-colored corrugated metal. The roof is surrounded by greenery and other buildings in the background.
2.	Typical example showing slight peel back isolated areas of the prefinished metal covering.

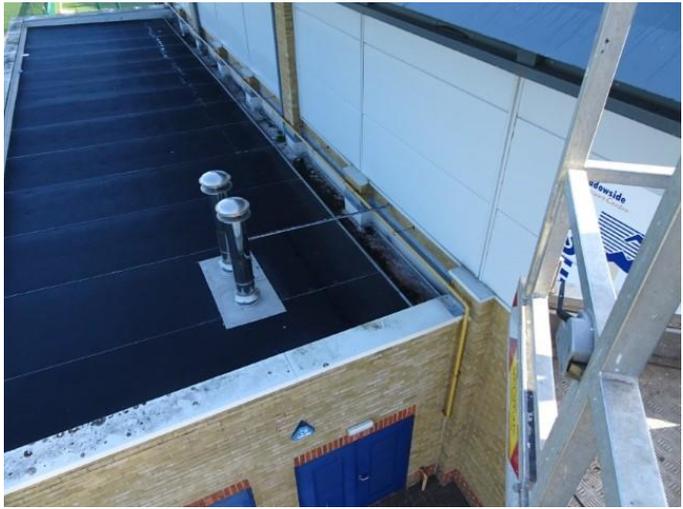
2.1.14. The flat roof is weathered with a single ply membrane system, with perimeter flashing to abutments and the parapet perimeter, and a coping detail to the parapet wall. Whilst there was a minor build-up of soiling and staining generally, the systems appears to have been installed recently and to a good standard. Any build up of debris should be cleared on a regular basis as part of a general maintenance regime.

<p>4.</p>	<p>Typical view of the single ply roof covering above the changing block and plant room area.</p>

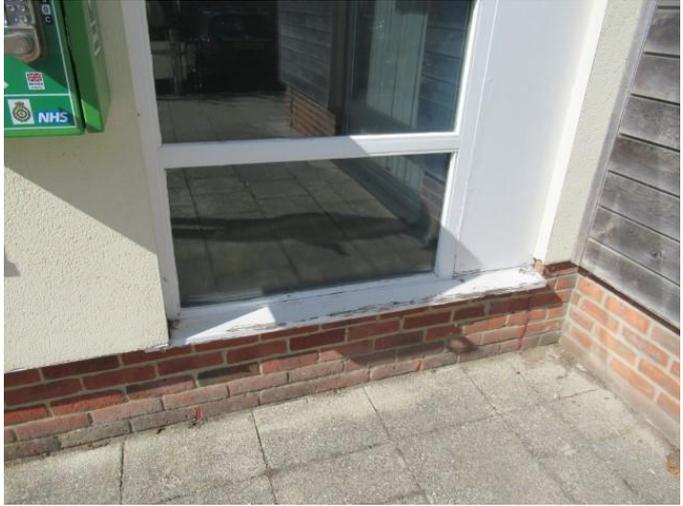
- 2.1.19.** The windows and doors to the main building are generally in fair condition. To some areas, the decorative coating has faded with localised areas starting to peel back. It is advisable that maintenance is carried out on a regular basis to prevent further deterioration of the metal and timber frames, and to keep the opening lights in working order. We have allowed for general overhauling works along with a medium term redecoration/restorative coating within the schedule.

<p>6.</p>	<p>Typical example showing decorative wear and tear to the timber window cills</p>

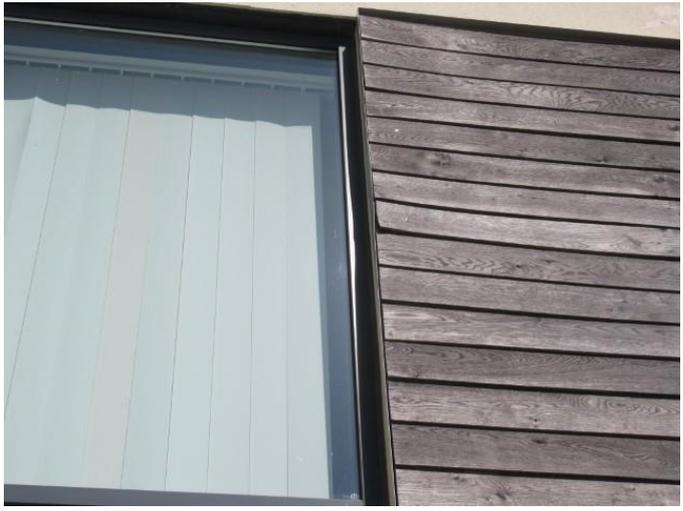
- 2.1.17.** The timber cladding to the new extension has naturally weathered over the course of the years. A number of the boards have curled slightly, with some splits observed around the knots. Whilst this is only of a cosmetic concern, the timber sections would benefit from a treatment coating in the long term.

7.	Typical view of timber cladding.

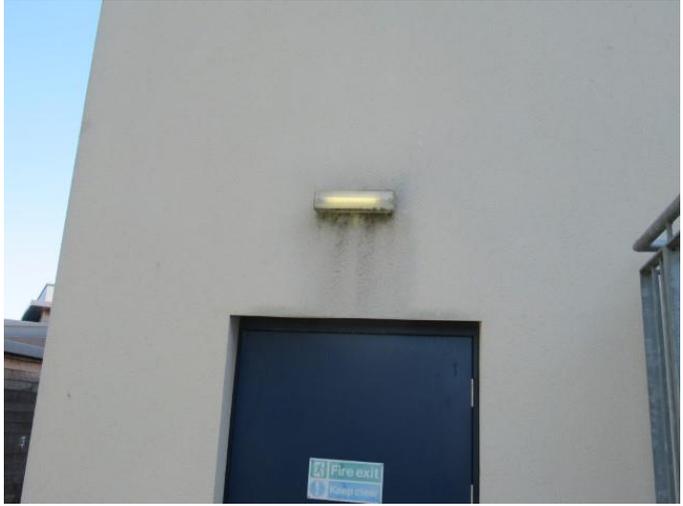
- 2.3.13.** Emergency lighting is provided throughout and include an assortment of integral light fitting and bulkhead lights. Twin spot emergency lights are also provided to the sports hall area. Each of the external fire exit doors are provided with emergency bulk head fittings, however, some of these appear dated poorly maintained. We recommend that older type fittings are replaced. The system should be tested on a yearly basis as part of routine maintenance and recommend that existing documentation is requested from the service provider.

9.	Typical example of emergency bulkhead light.

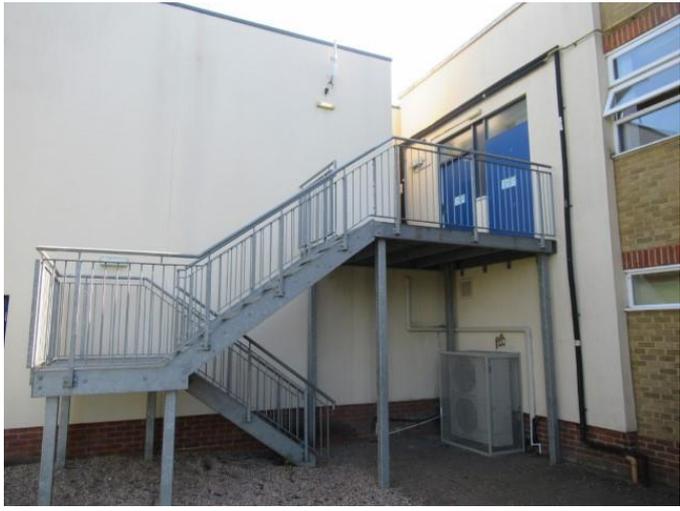
- 2.1.23.** The galvanised stairs to the rear elevation are in reasonable condition with no immediate concerns to raise with respect to their structural integrity. Whilst it is predominantly only used as a means of escape, the treads can become slippery during wet weather. We recommend an anti-slip coating is applied to the treads to mitigate the risk of falls.

10.	General view of the rear fire escape stairs.

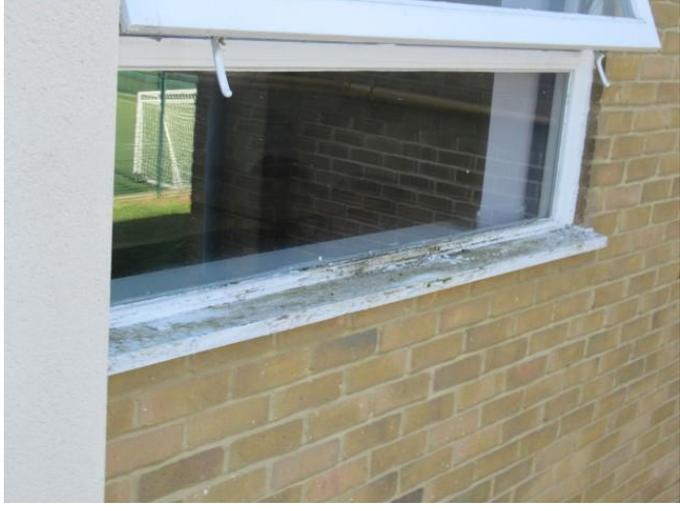
- 2.1.20.** Whilst the original timber casement windows are functioning well, there are spot areas of rot and decay to isolated areas of the frames. Along with the redecoration works and overhauling, an allowance has been made for timber splice and epoxy repairs to worse affected areas in the short term. It may be advisable to consider wholesale replacement for matching prefinished metal windows in the long term (i.e. similar specification to that used on the recent extension). This would have the added benefit of reduced maintenance liabilities and improvements to the properties thermal performance.

11.	Typical example showing decorative wear to the timber window casements along the North elevations.

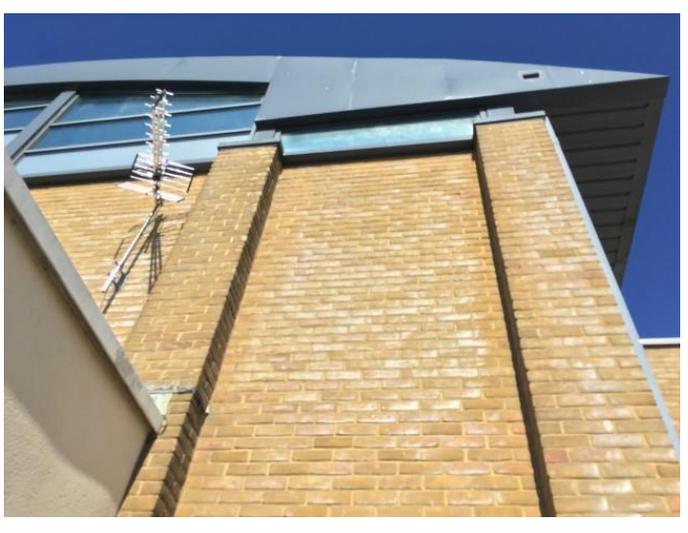
- 2.1.16.** The brickwork and render are generally in reasonable condition, with only some minor salt staining and lichen growth noted to the surfaces. Minor hairline cracks to the render were observed above the fire exit doors from the gym area (most likely attributed to seasonal movement) along with some missing and spalled sections to small isolated areas. Mastic movement joints are provided to the rendered bays of the extension. These appear to be performing as intended. Other than some a general cleaning and some short to medium term cyclical repairs, there are no other immediate concerns that warrant further investigation.

13.	Minor salting to the brickwork.

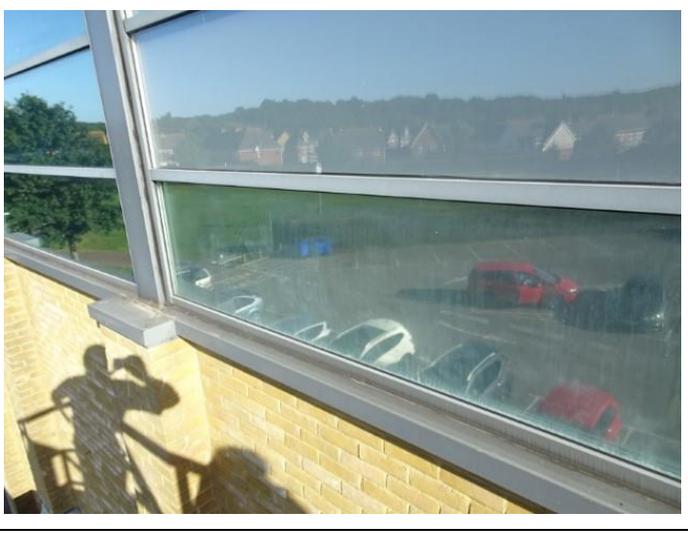
- 2.1.21.** It was noted that a number of the glass units to the triple glazed system installed to the south side of the sport halls have failed. Misting was evident within the sealed units. Elements of the solar film are deteriorating also, peeling and mismatching in places. Whilst not an immediate concern, we recommend that failed windows are replaced in medium/long term with a more suitable system. It may be prudent to seek further advice regarding repair and replacement from a curtain walling/glazing specialist.

14.	Typical example showing misted glazing units to the south sports hall elevation.

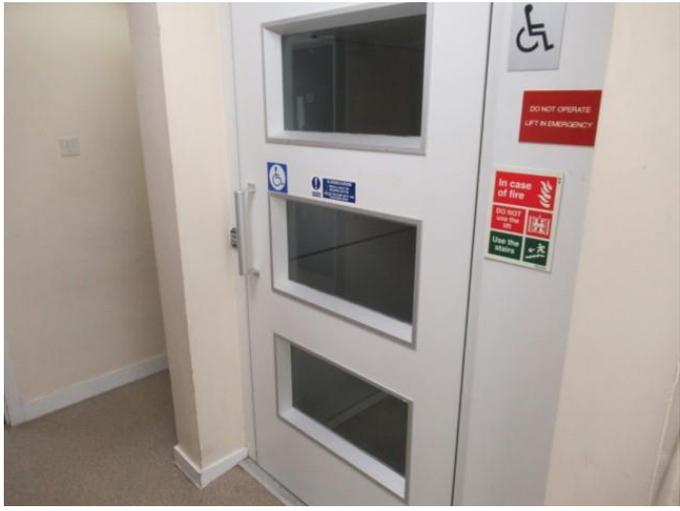
- 2.3.18.** A platform lift provides access to and from the first floor level adjacent to the stairs. Whilst the lift is dated, and surfaces are worn it is operable and in working order. We recommended testing and maintenance records are requested from the service operator.

19.	General view of the enclosed platform lift operating from ground to first.

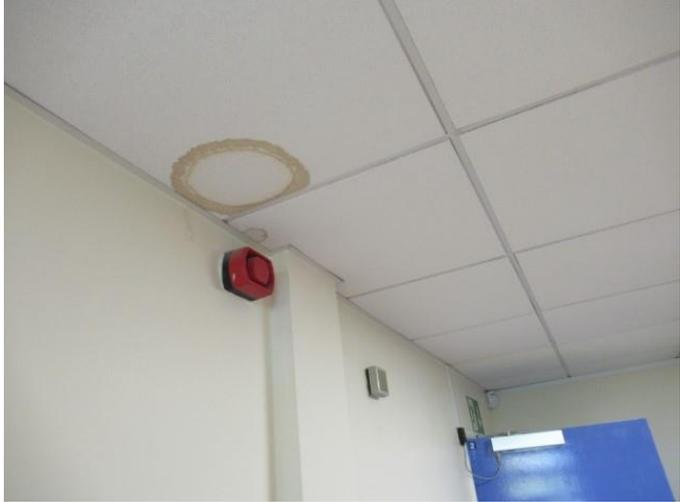
- 2.1.36.** The decorative condition is fair, albeit dated in appearance and has suffered from a degree of wear and tear throughout. Damp staining and impact damage were noted to numerous ceiling tiles, notably below the gutters. The floor coverings are generally worn and in need of a deep clean in the short term. Along with some minor remedial repairs, these areas would benefit a complete redecoration in the medium to long term along with wholesale replacement of the suspended ceilings and floor finishes in the long term.

21.	Isolated damp ceiling tiles within the function rooms to the first floor.

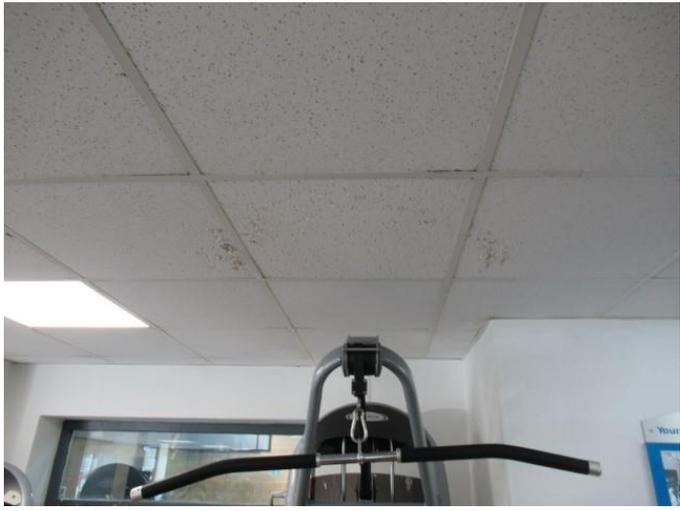
25.	Typical example showing isolated damage to the mineral fibre ceiling tiles.

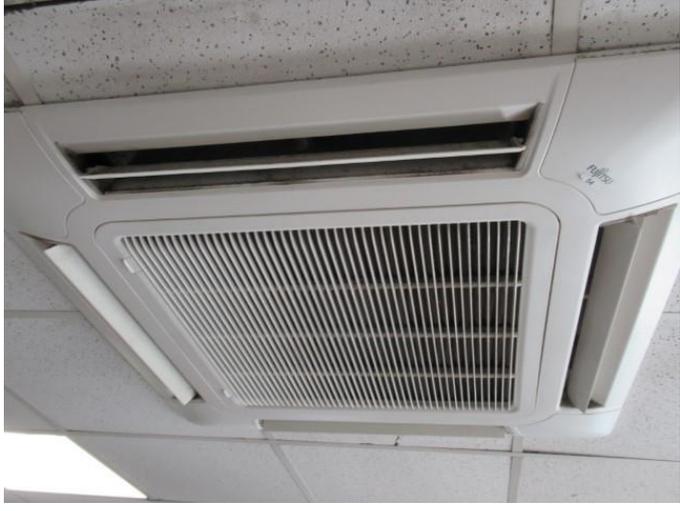
- 2.3.9. Local means of cooling is provided to the gymnasium and studio areas to the ground floor. Each of these spaces are provided with DX ceiling mounted cassette units, with the cabling and refrigerant pipework connected to the external condenser units. The original manufacturer date is 2016 with A410A coolant provided to each. Whilst these are generally performing well, we recommend these are tested and serviced. The serviceable operational life remaining to the systems should surpass the long term if routinely tested and maintained.

26.	Typical example showing a comfort cooling unit within the gym areas.

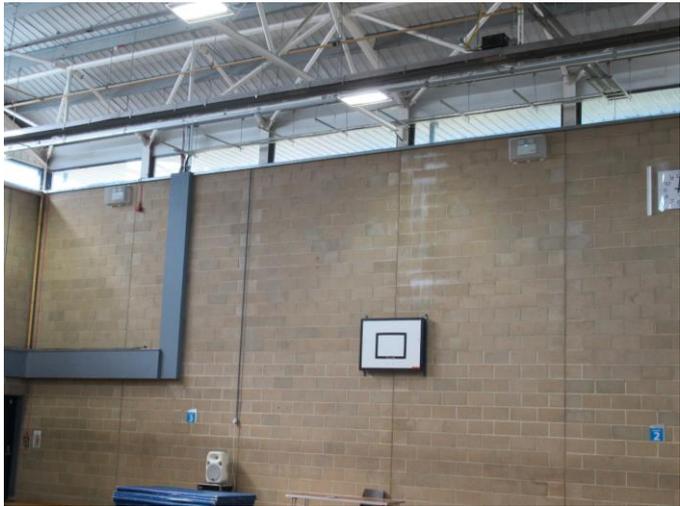
28.	Salting to the brickwork within the sports hall area.

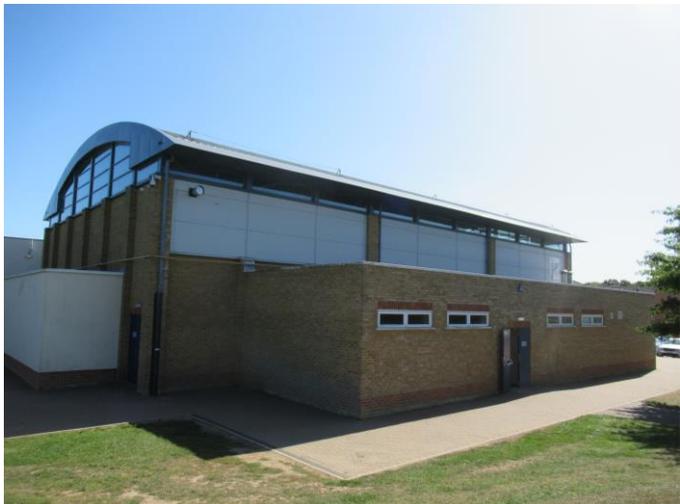
2.2.2. The hardstanding areas are generally in reasonable condition. Minor patches of weed growth and some open joints were noted to isolated areas of the block paved pathways. The tarmac to the carpark is slightly worn, with isolated areas where surfaces are breaking up. The line markings to the bays are also beginning to fade and there is some minor cosmetic damage to the concrete kerbstones. Whilst not of an immediate concern, we recommend that the carpark is resurfaced along with all bays relined in the medium to long term. Spot repairs will be required in the short to medium term.

30.	View of hardstanding to the side and rear of the sports hall.
