# Butter Cross Monument

PROGRESS REPORT No: 02

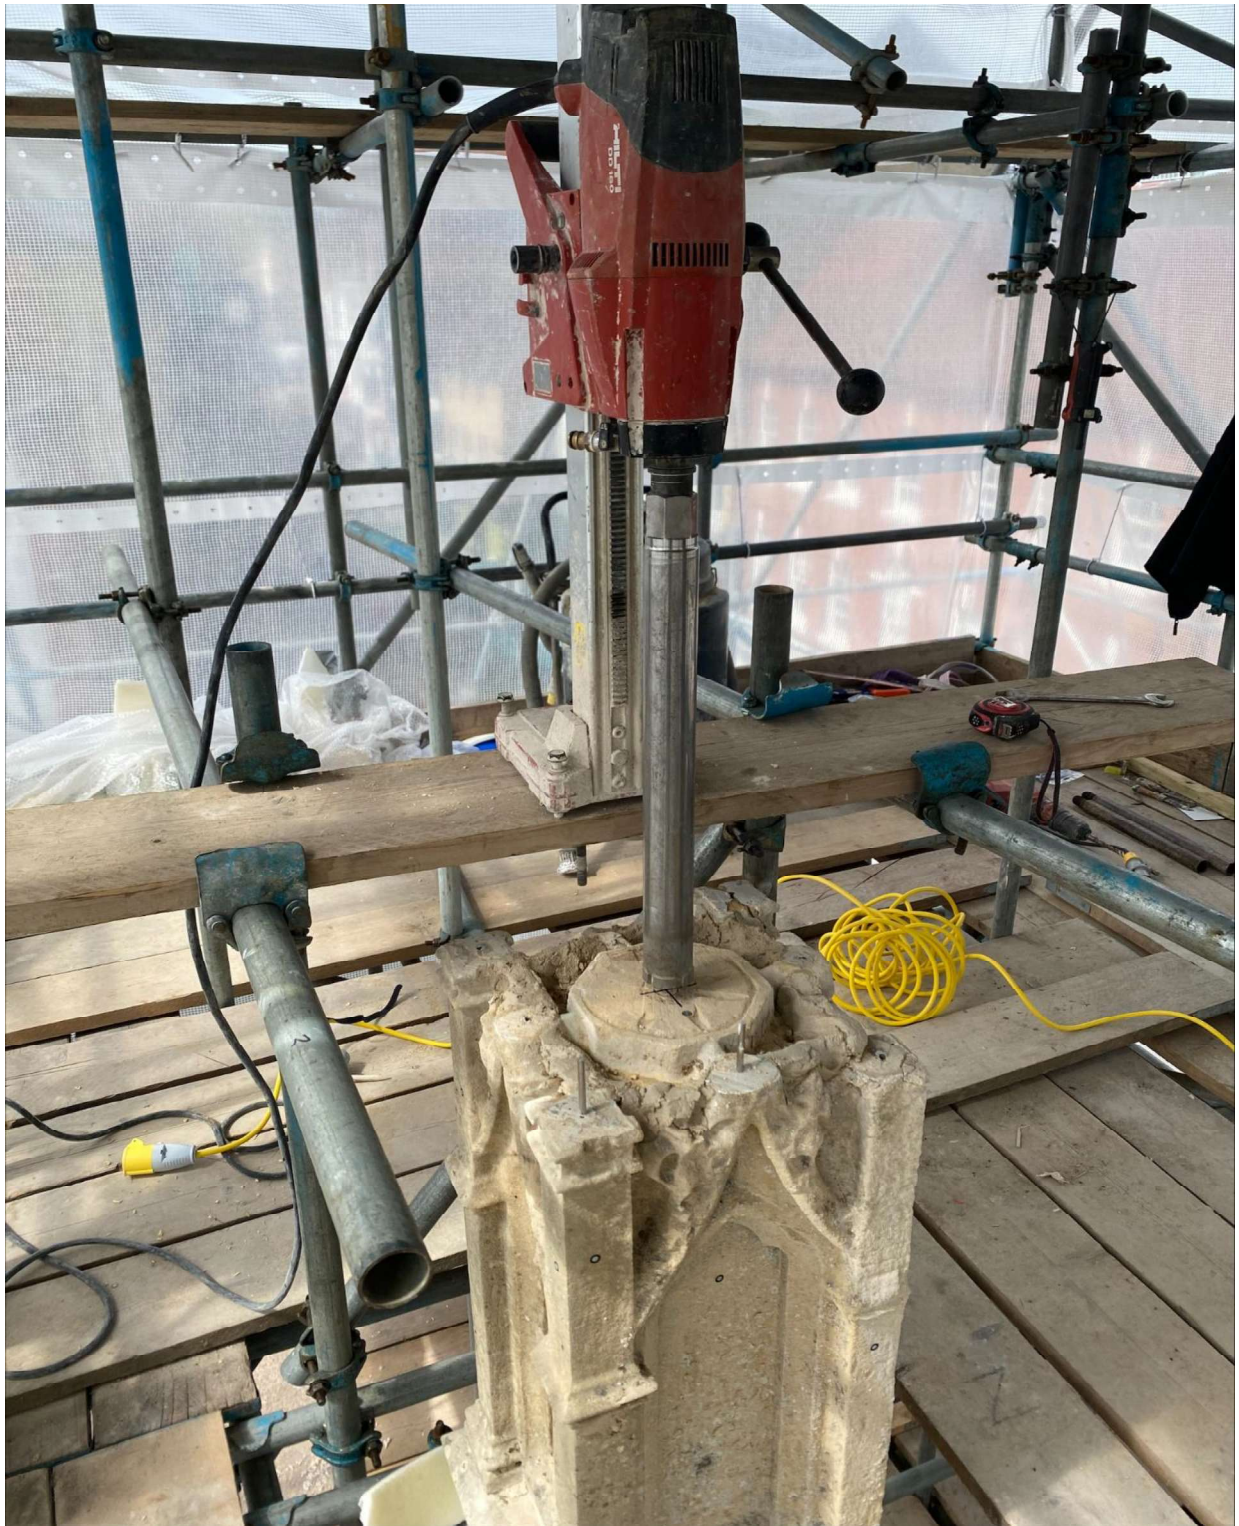
Photo showing core drilling rig to enable precise and careful removal of the ferrous fixings

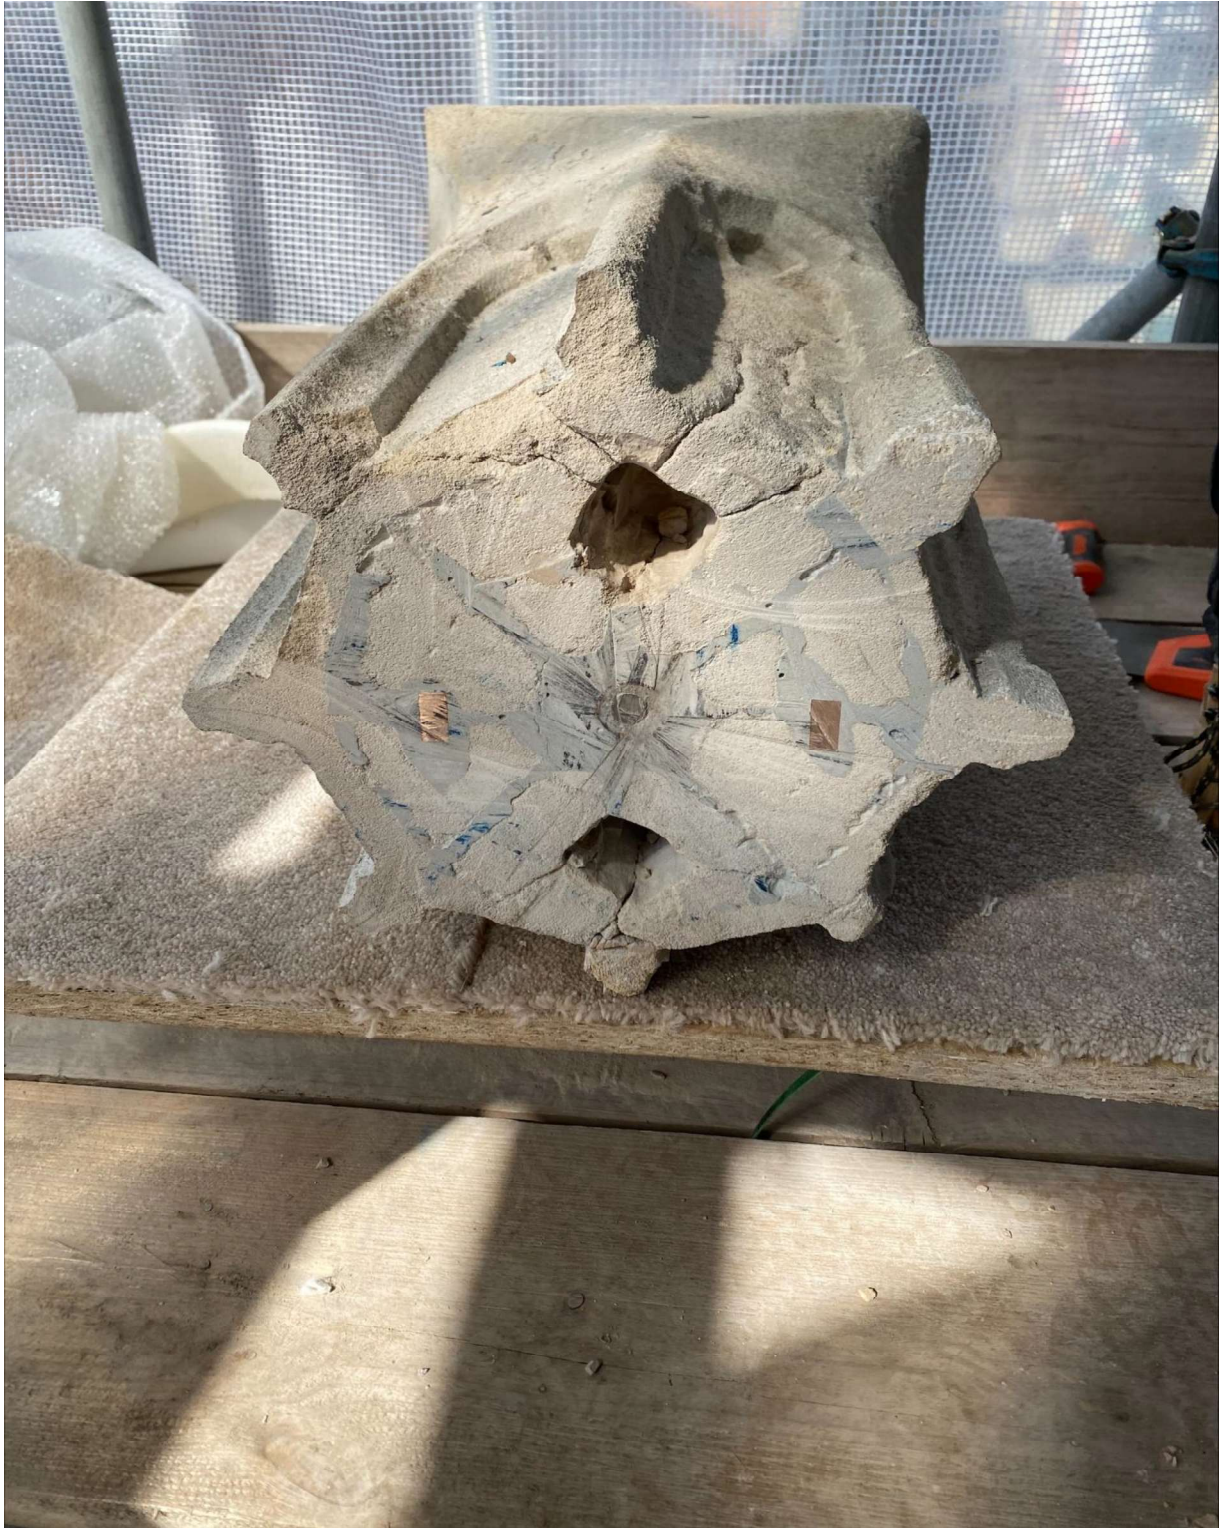
Photo showing cracking to the stone caused by excessive slate dowels located too close the outside of the stone, also the various different materials used for fixings- slate, stainless steel and brass

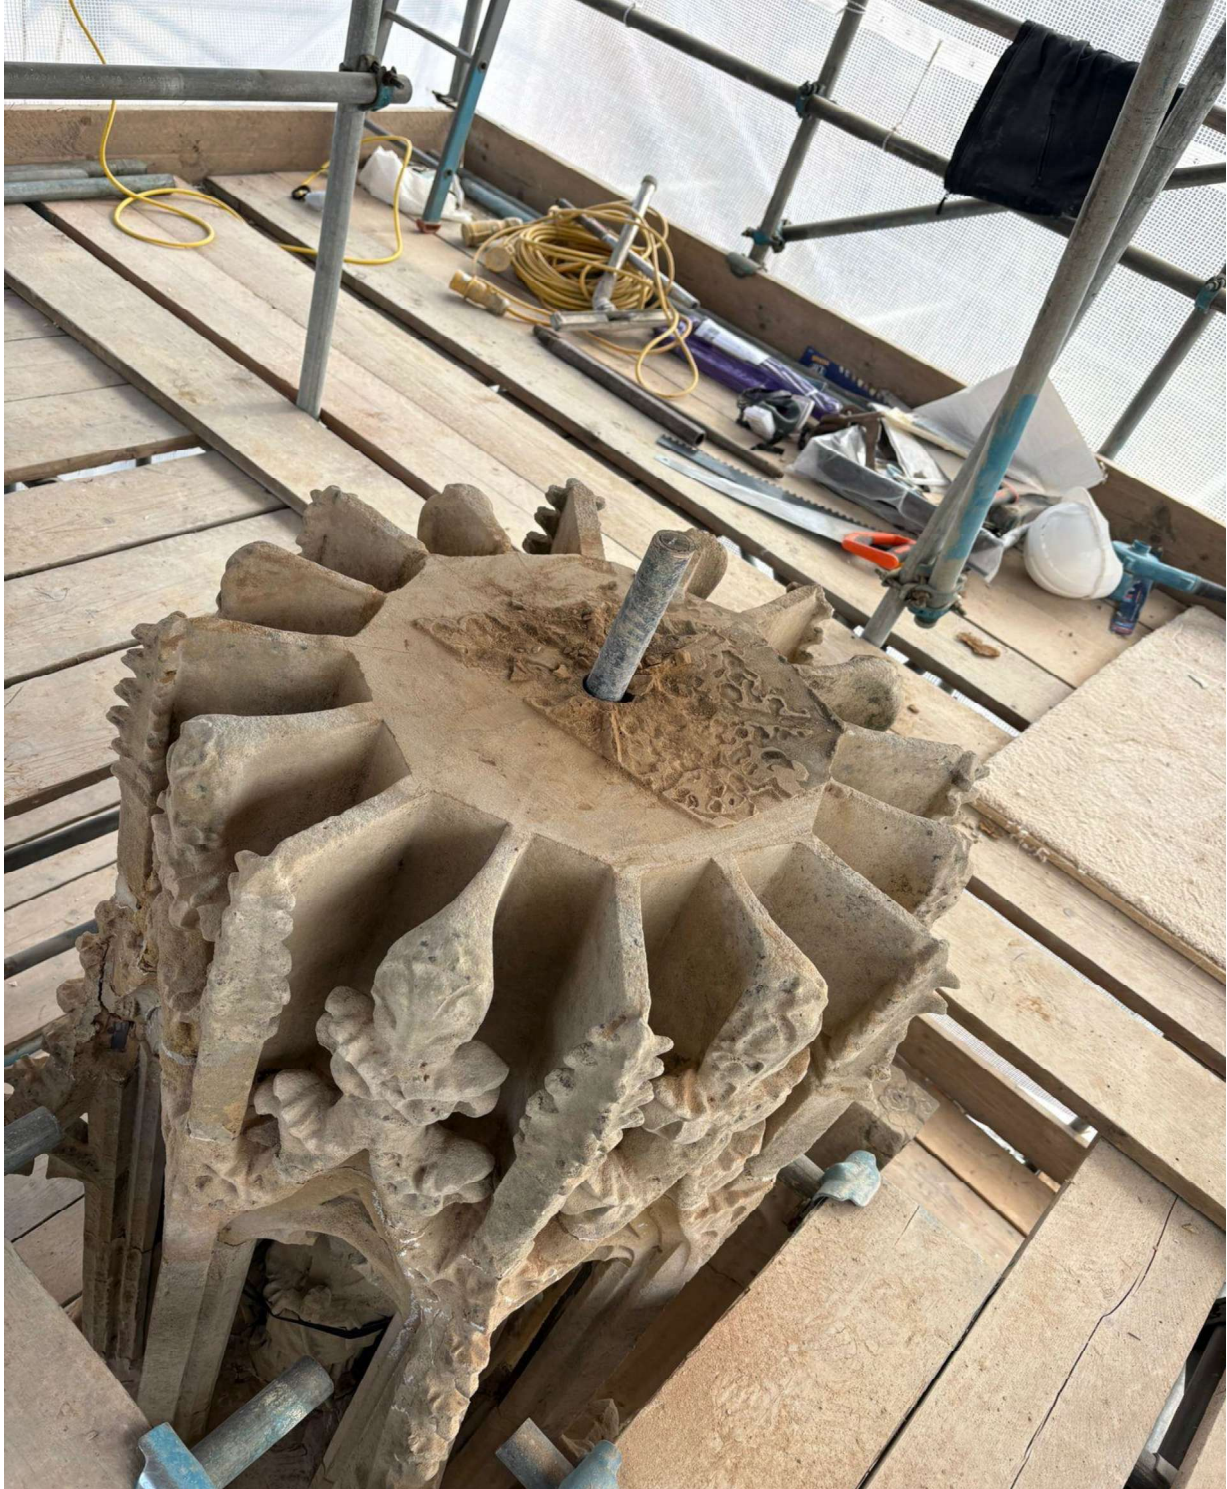
Photo showing the 40mm copper pipe used for fixing and the cementitious mortar in the bed joint. The hollow copper pipe was found to have two 8mm stainless steel bars within set in a cementitious type slurry

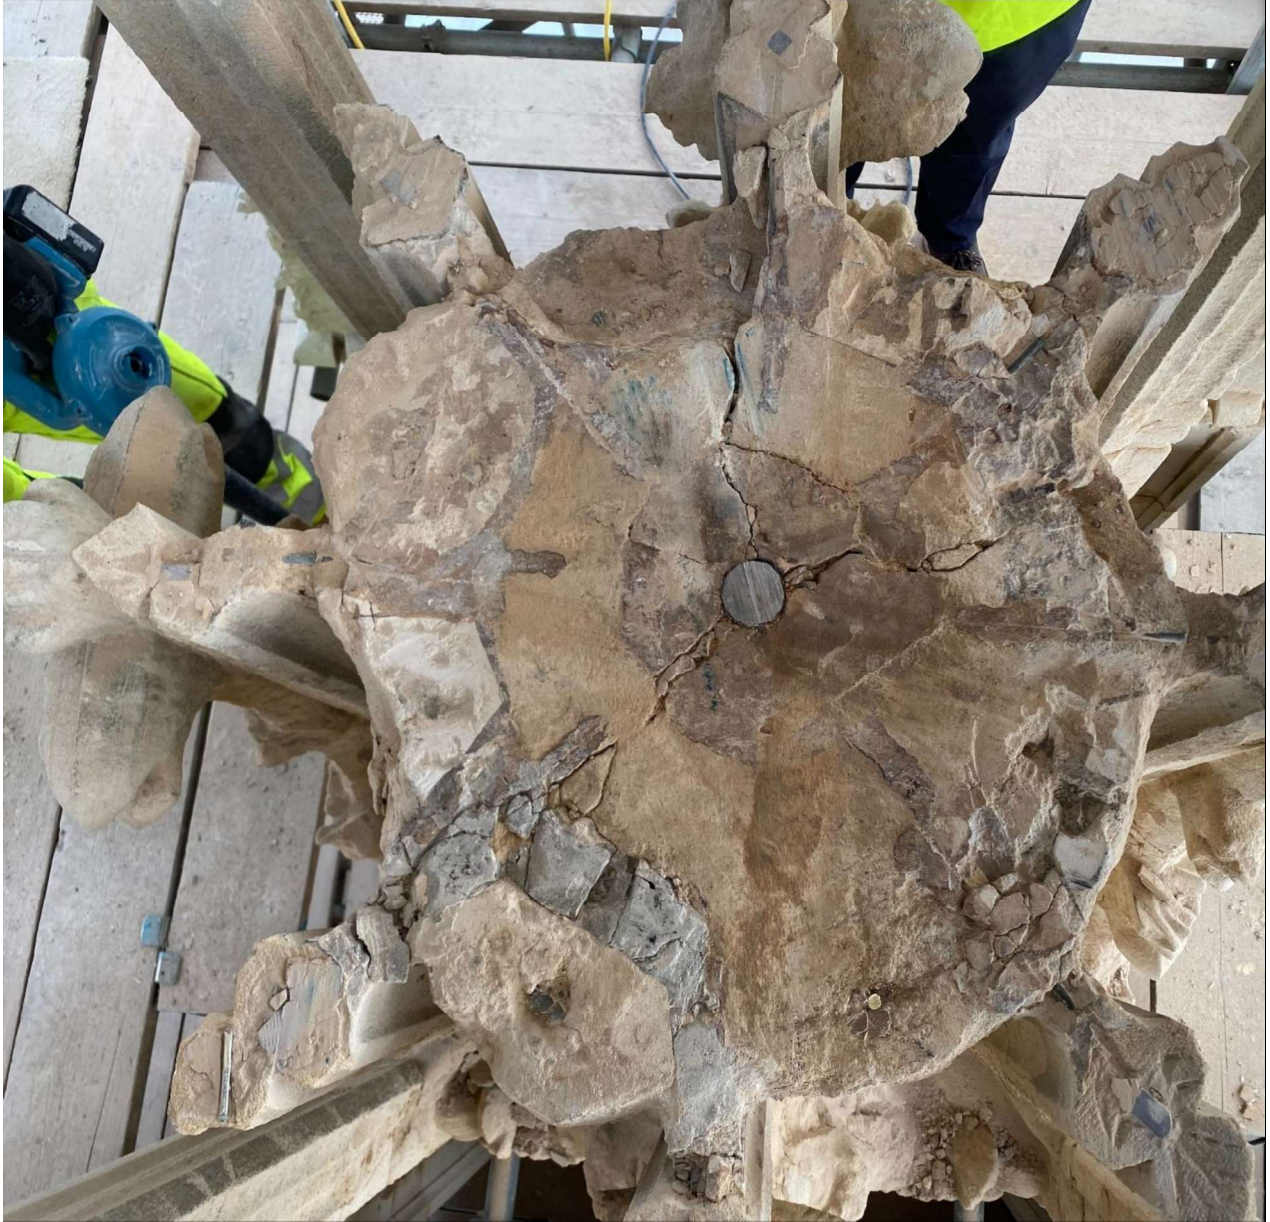
Photo showing the extensive vertical cracking to stone no N14a. Caused by the ferrous 40mm ferrous dowel used as the central fixing. We also consider when molten lead was poured to fill the void thermal shock may be a contributory factor to start the stone failure

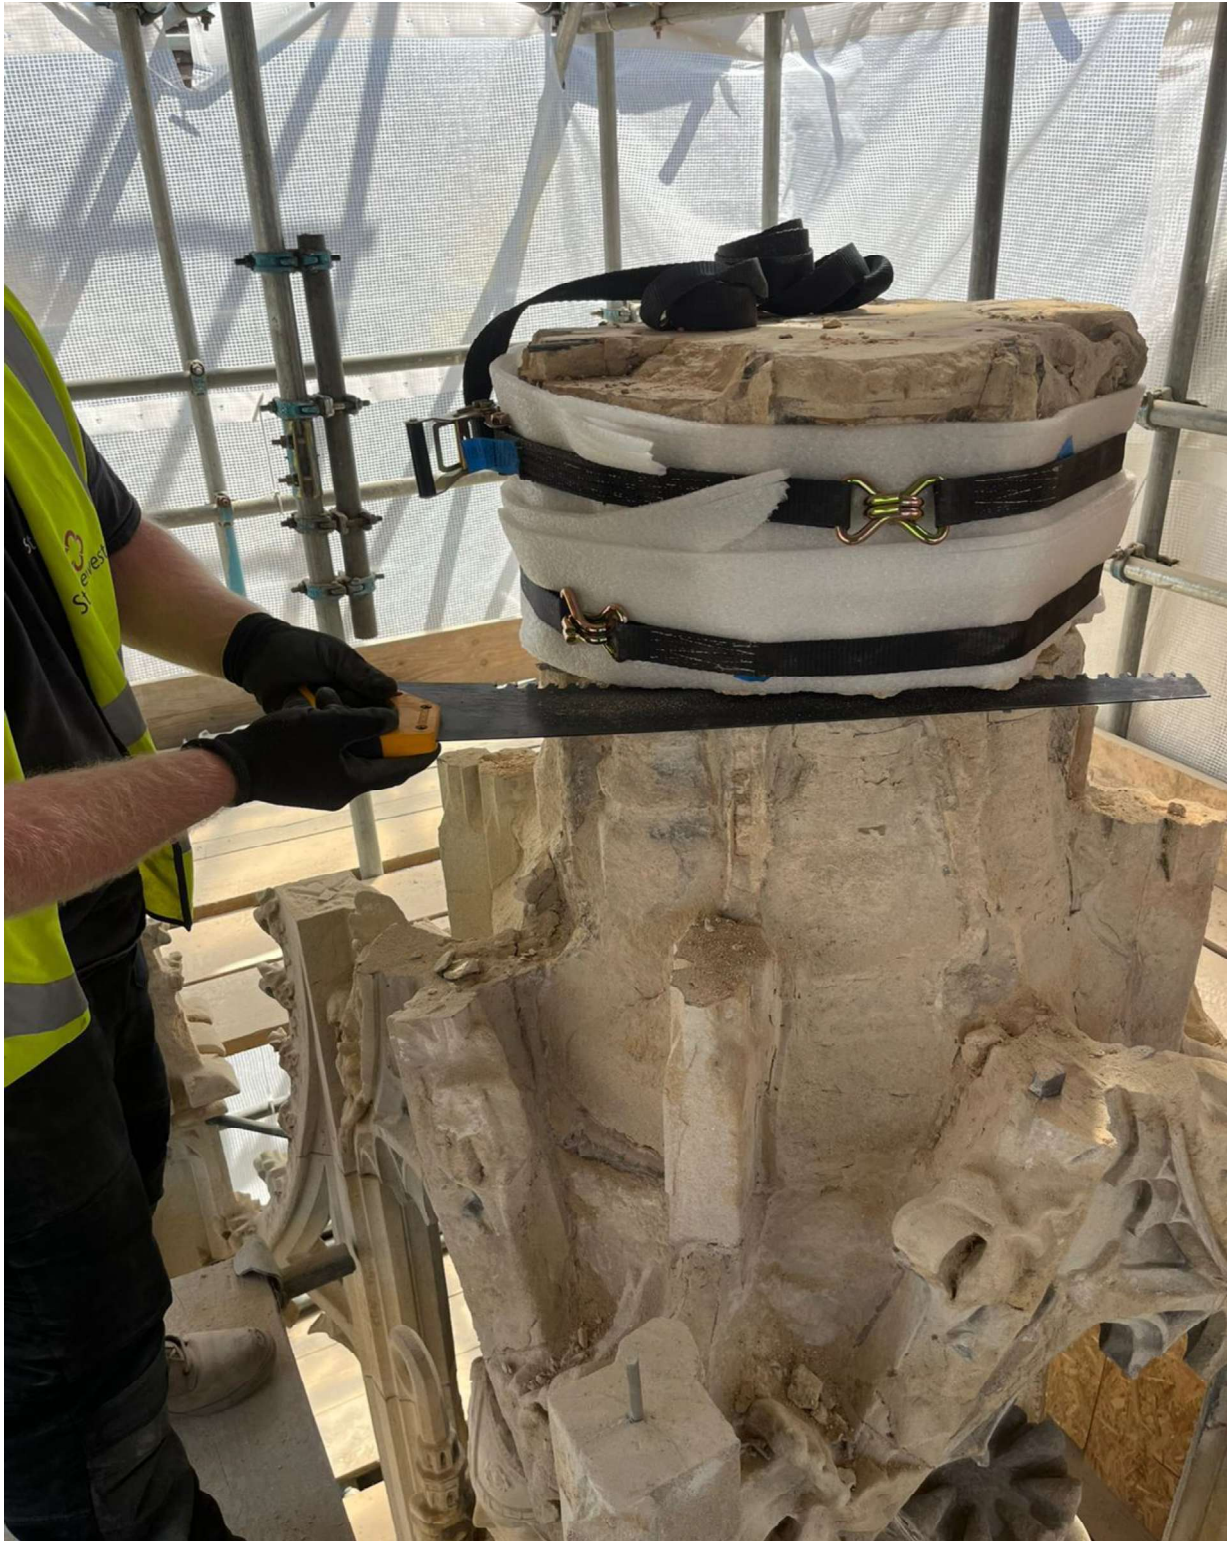
Photo showing SWL mason hand sawing bed joints using a traditional tungsten tipped masonry saw

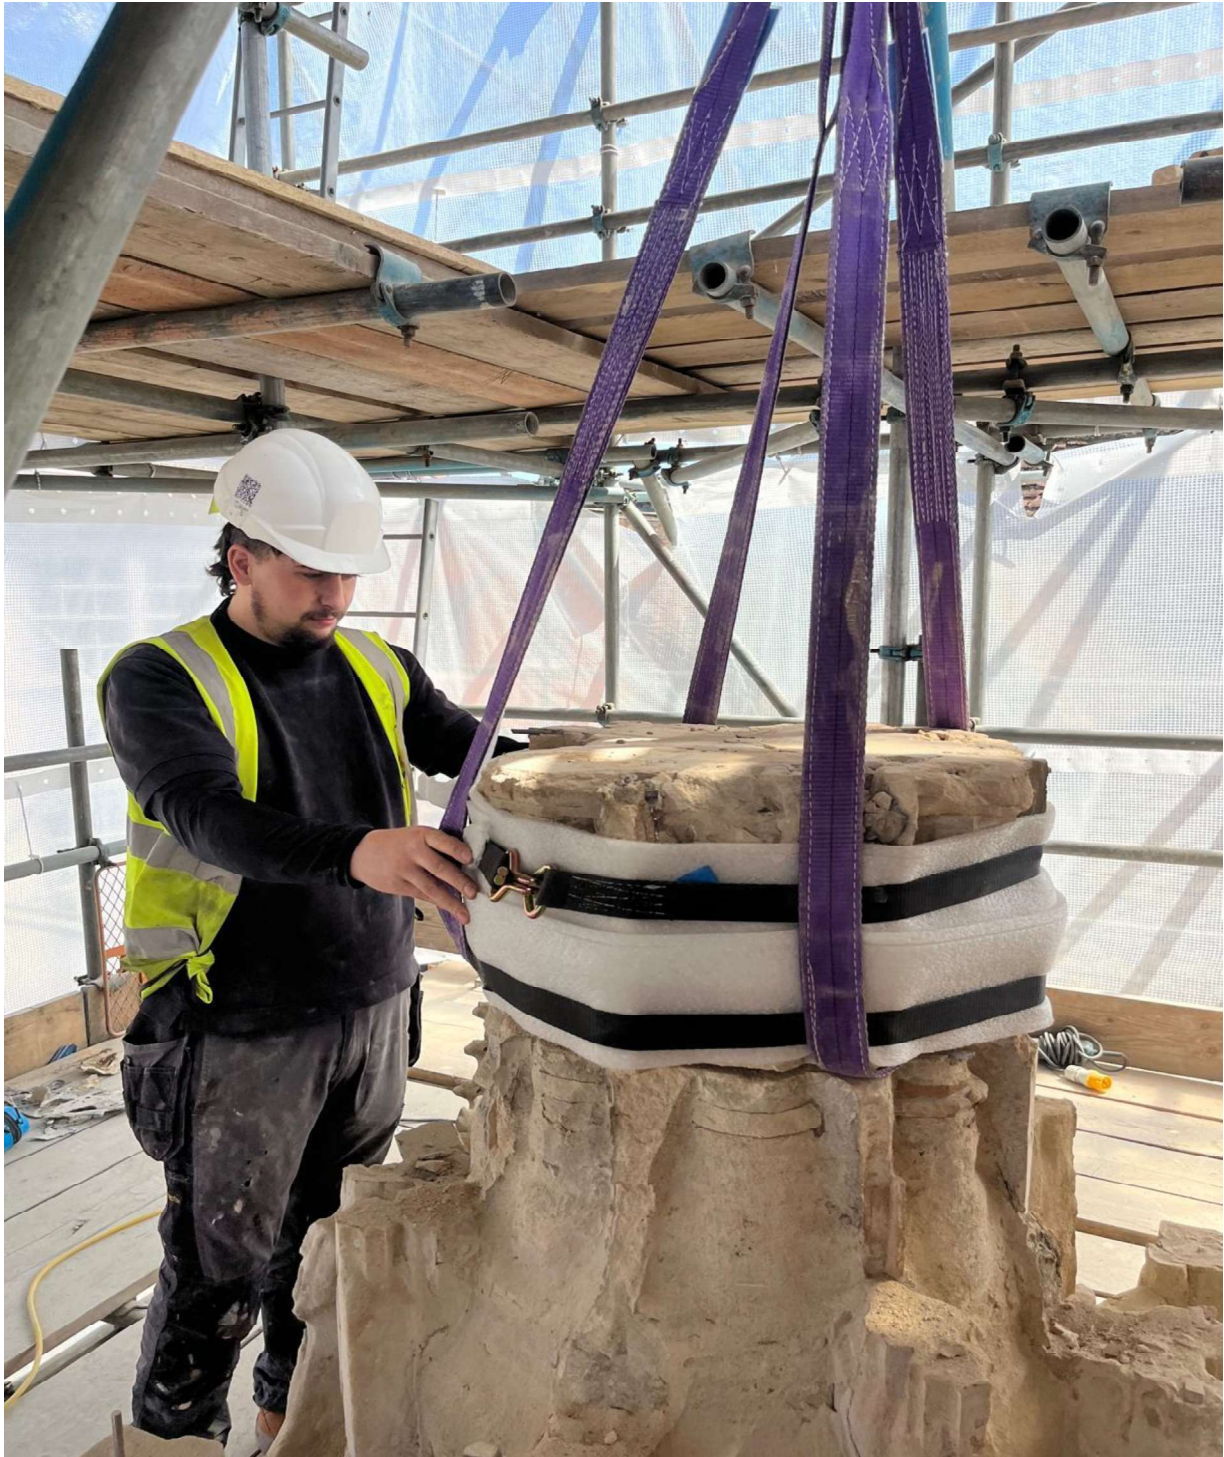
Photo shows SWL masons carefully and safely lifting stone no N14a off of its bed joint

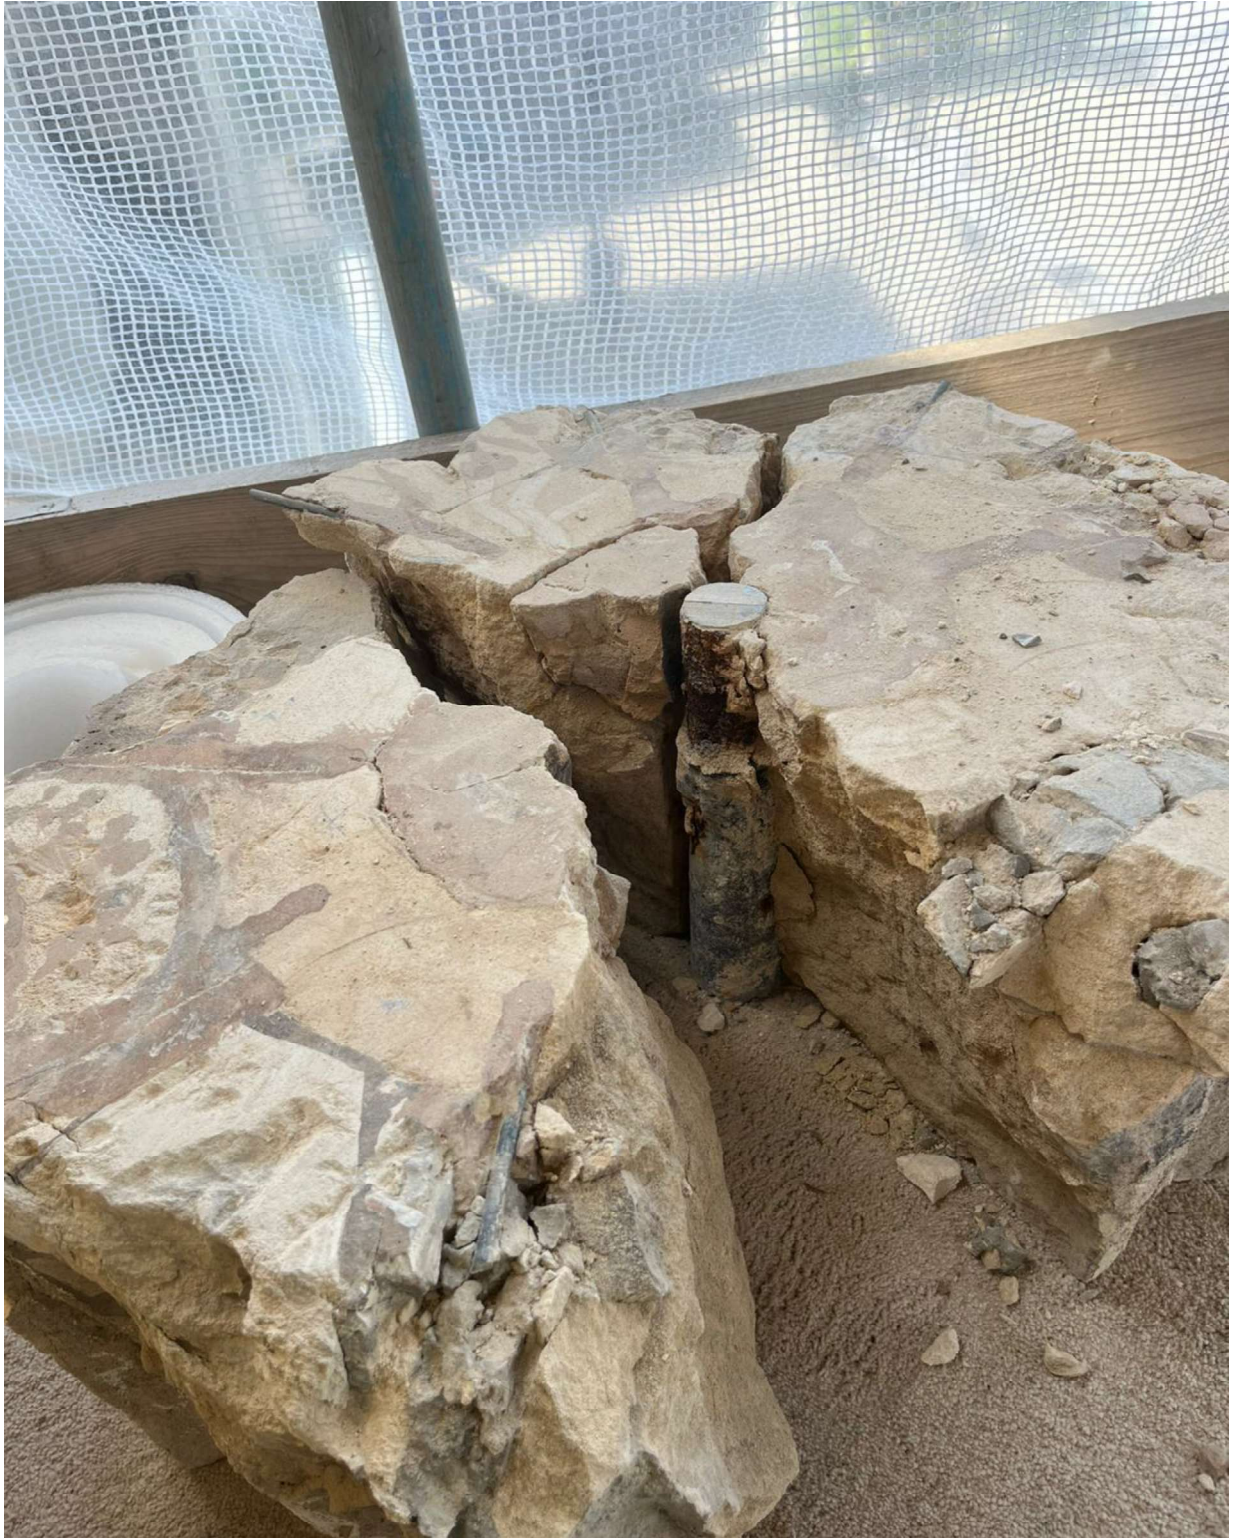
Photo showing the 40mm ferrous dowel (stone no N14a) . This also had a layer of poured lead infilling the hole that would have been drilled

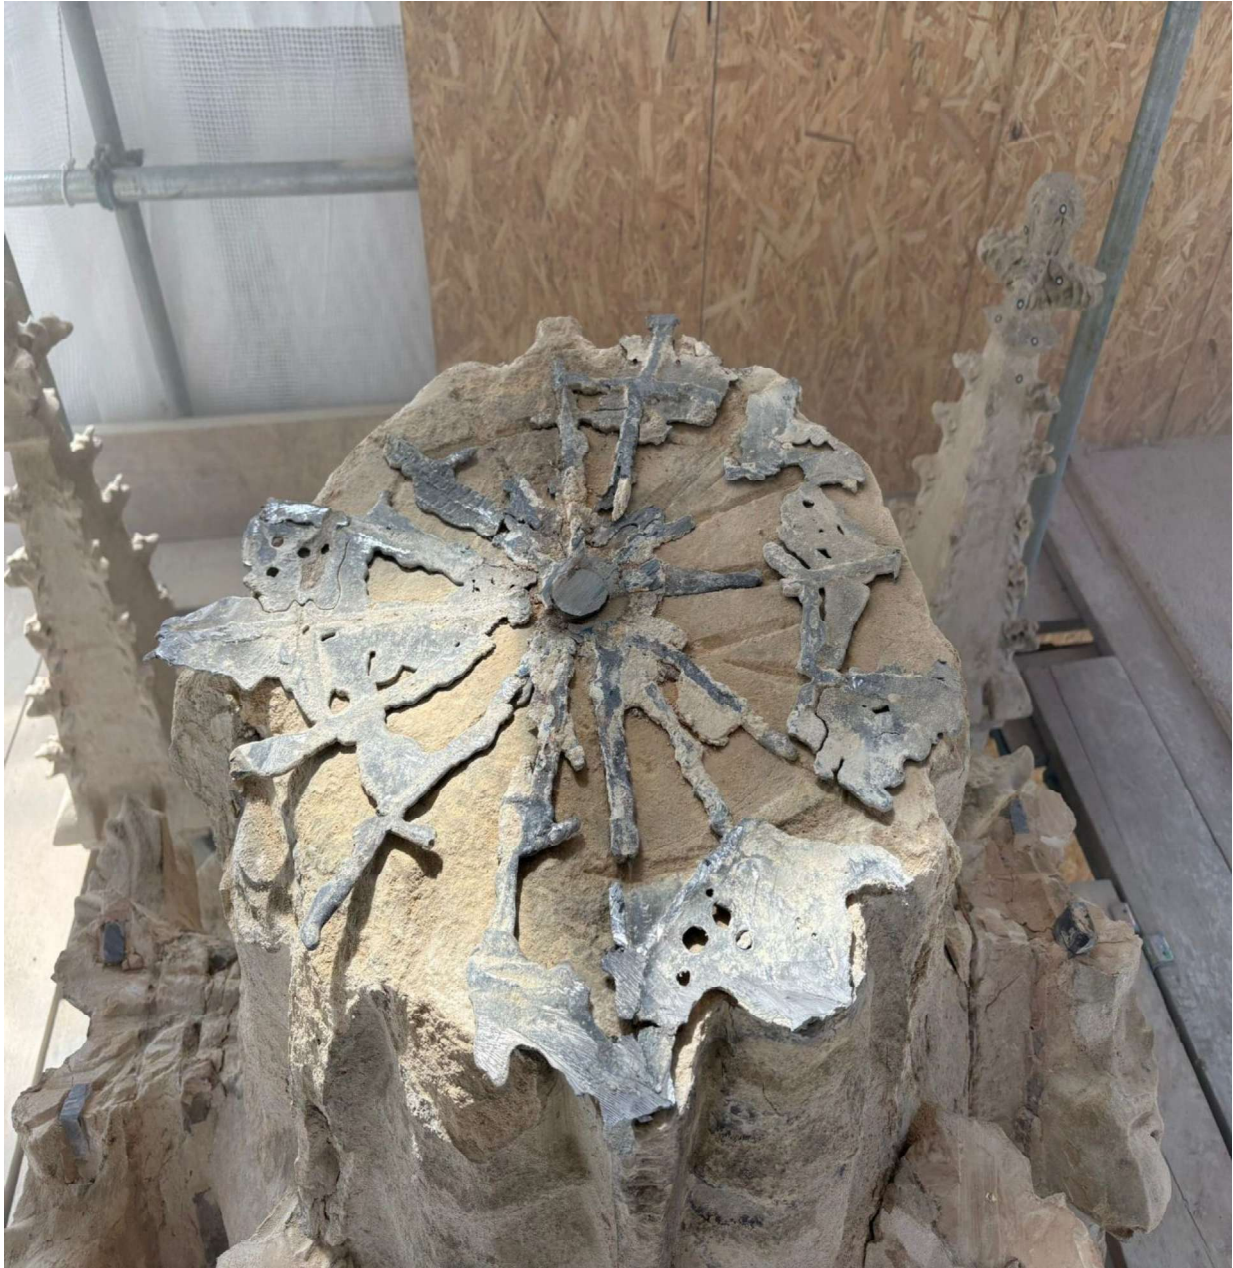
Photo showing the bed joint between stone no N14a and N14b.  
Poured molten lead was employed to act as an additional fixing into the joggle joints

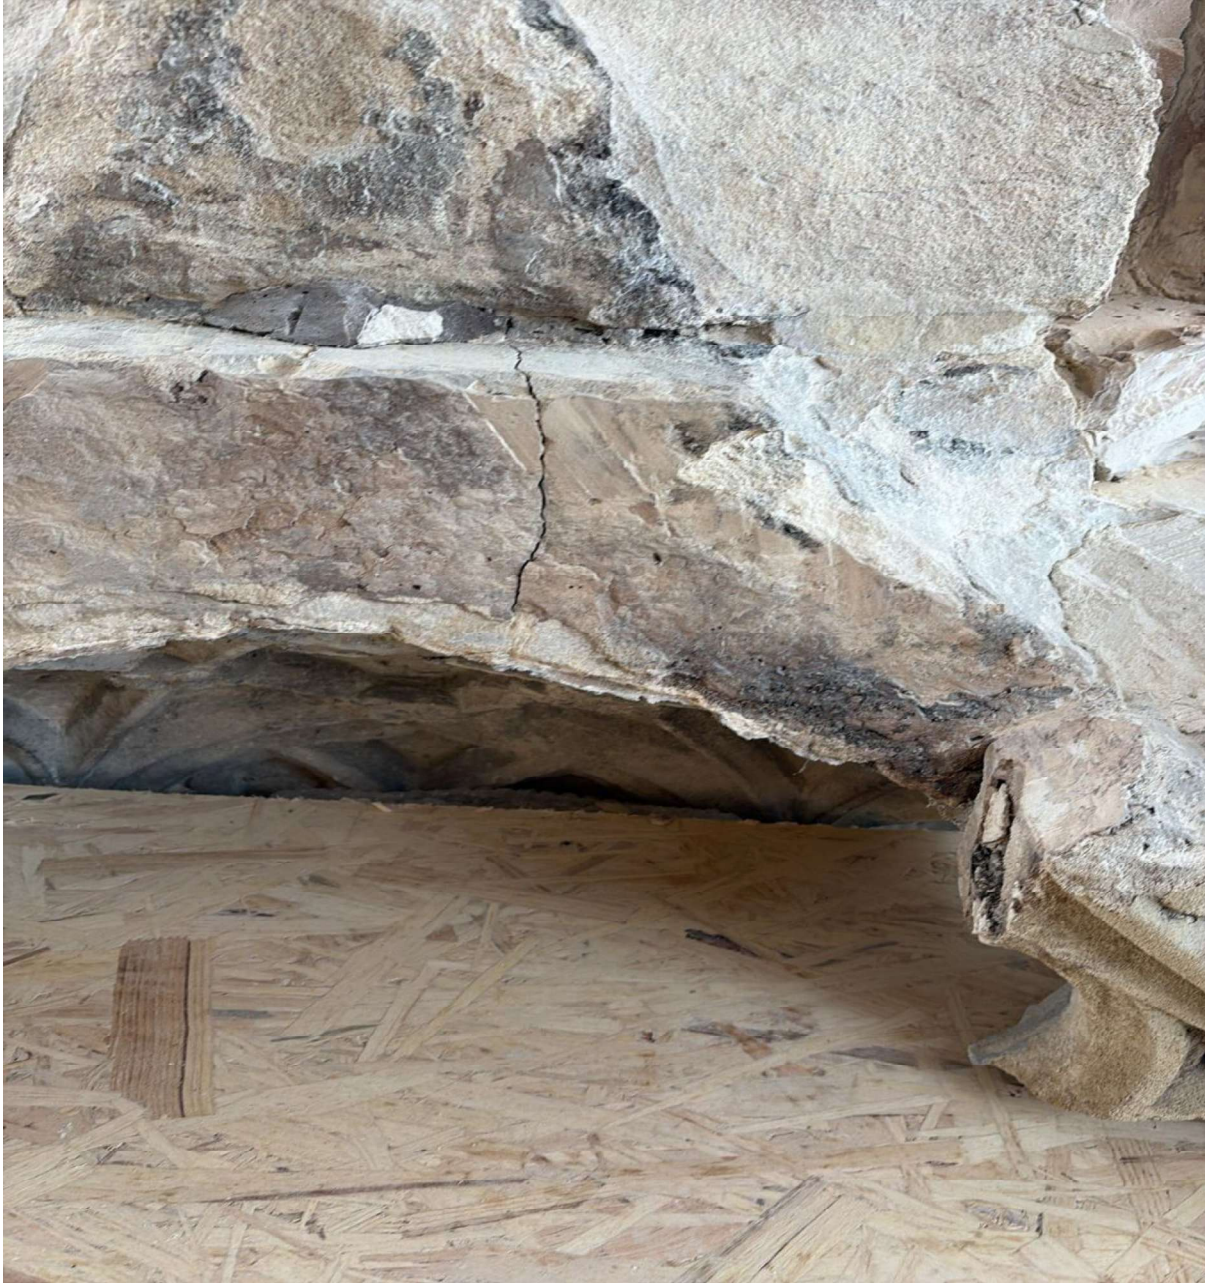
Photo showing the crack running North to South through stone no N17b, hooded stone above the large statues

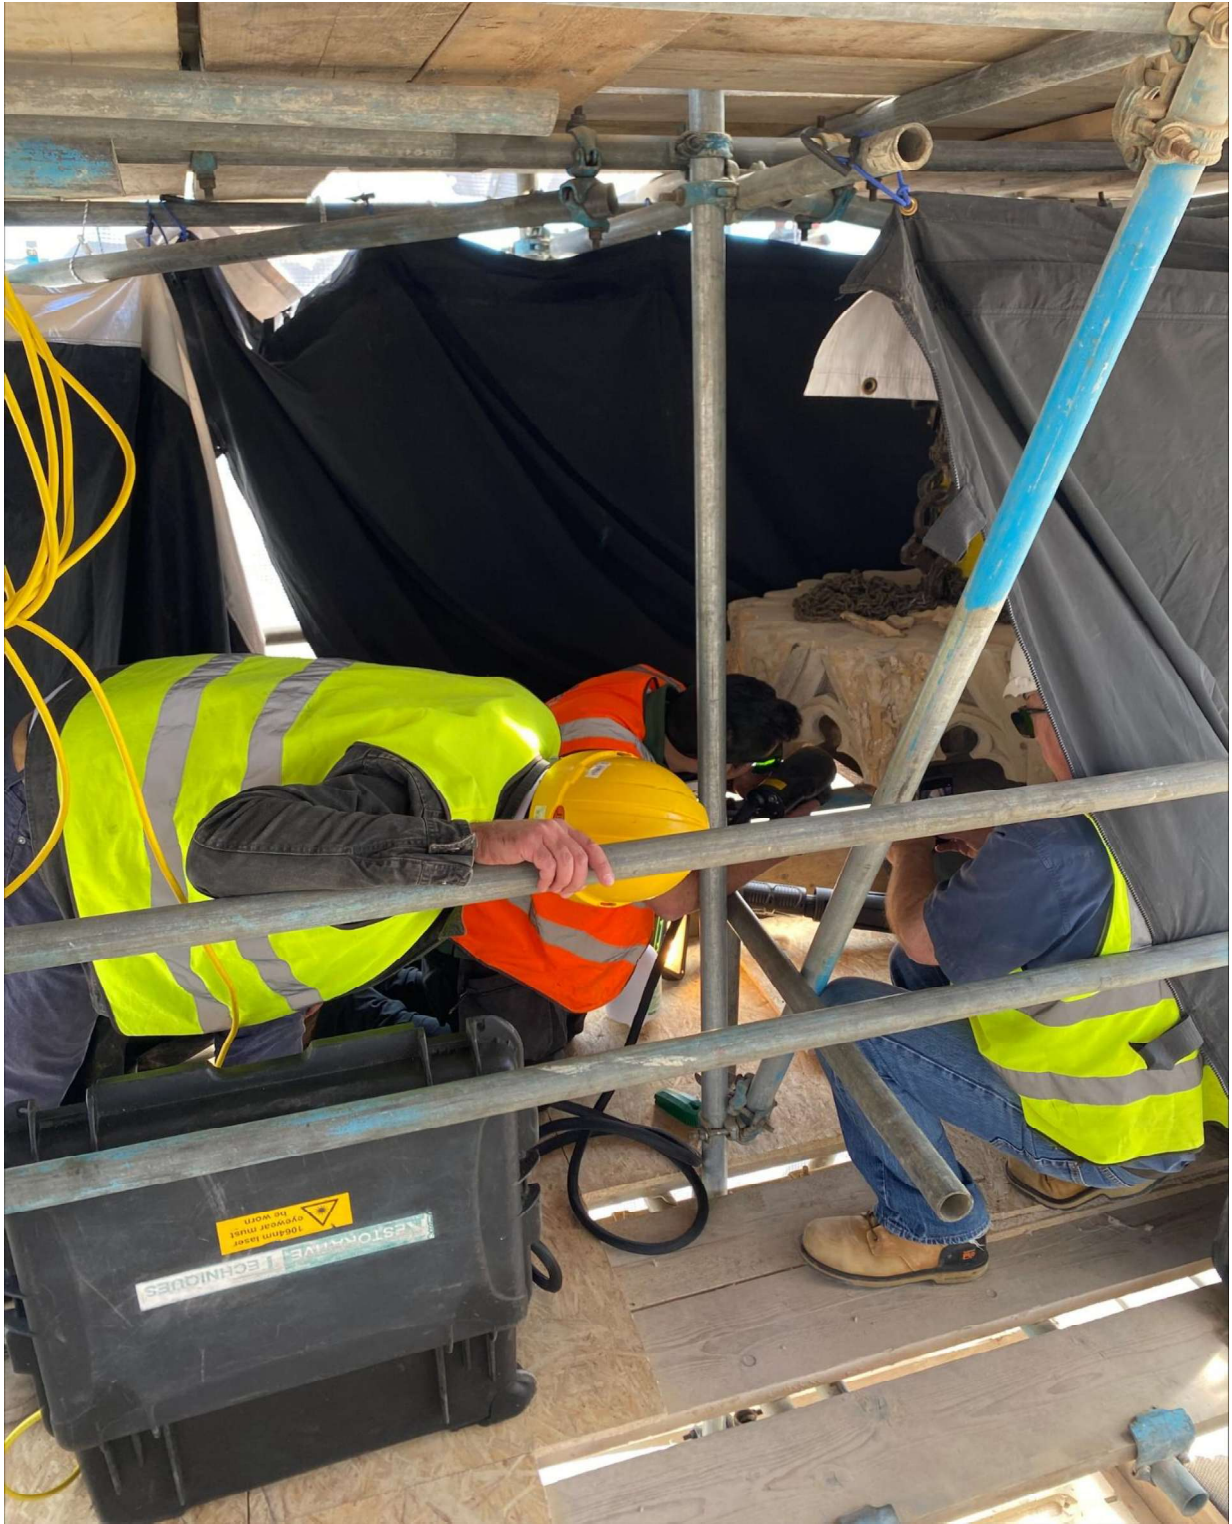
Laser cleaning trials carried out 30/04/26

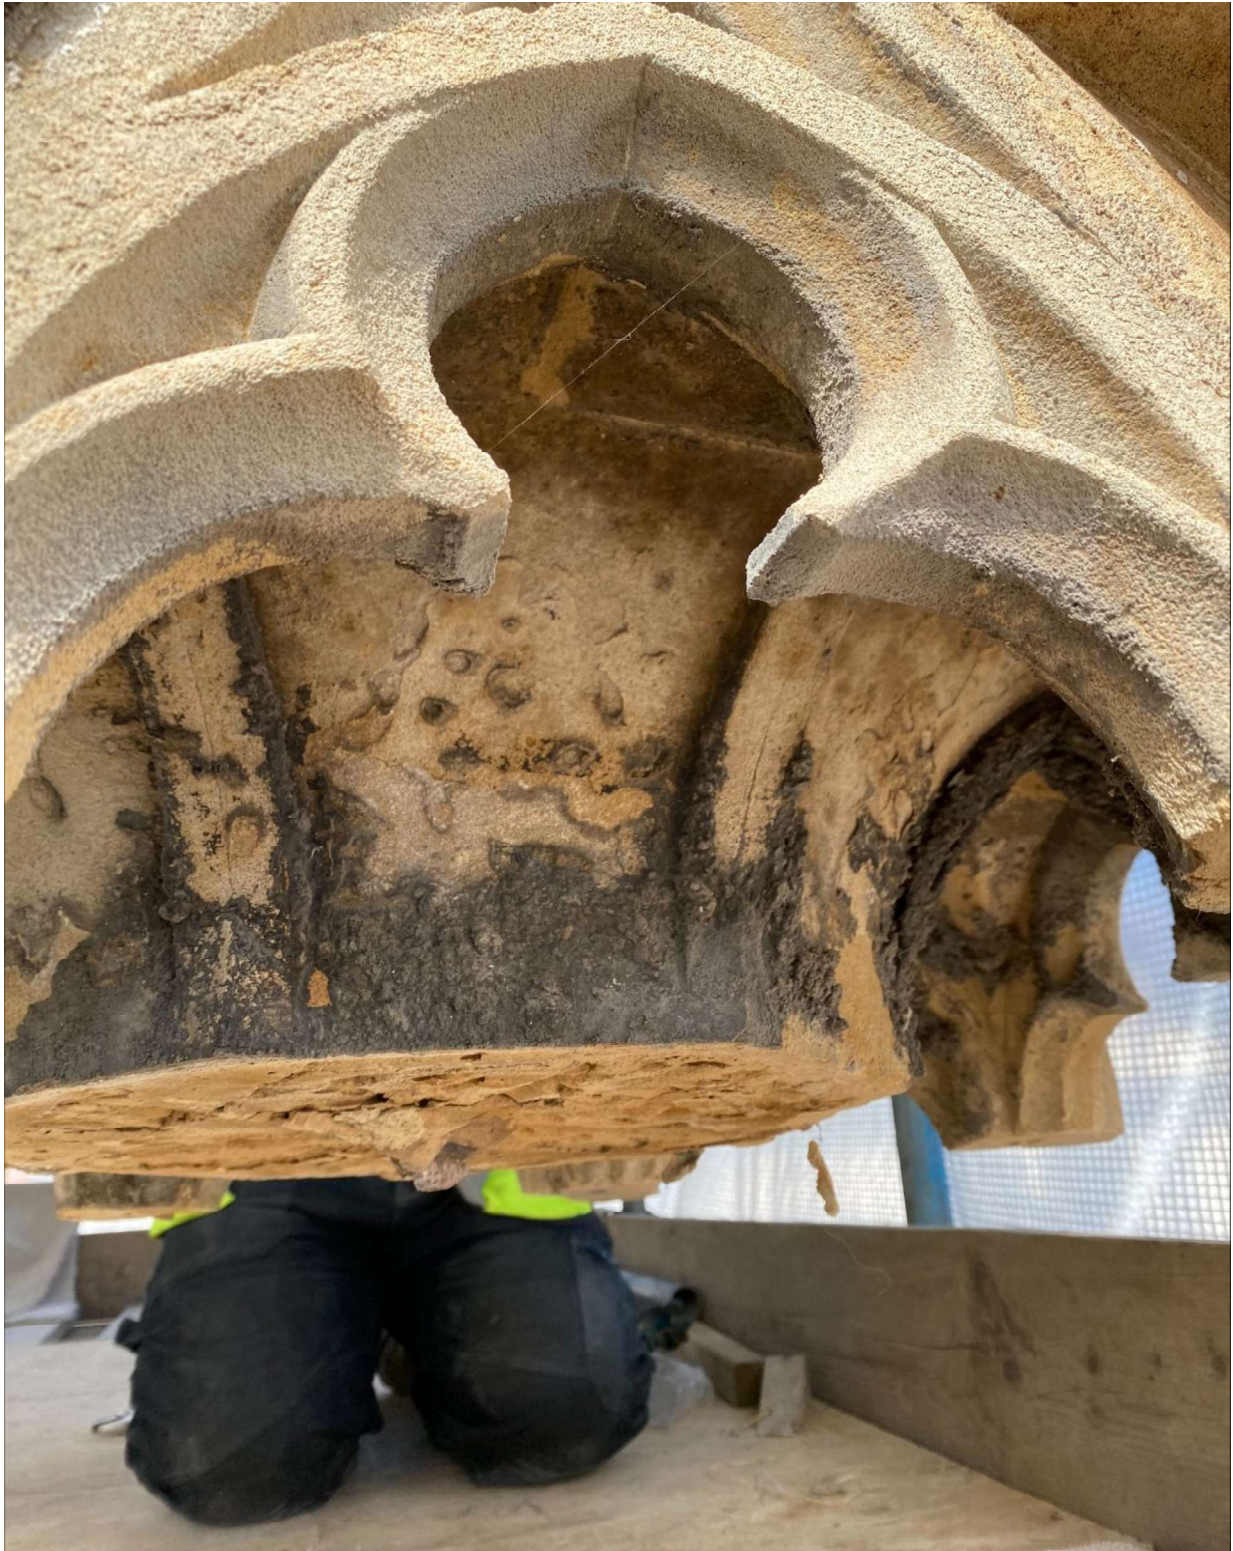
Stone number N9 before laser cleaning trials had taken place

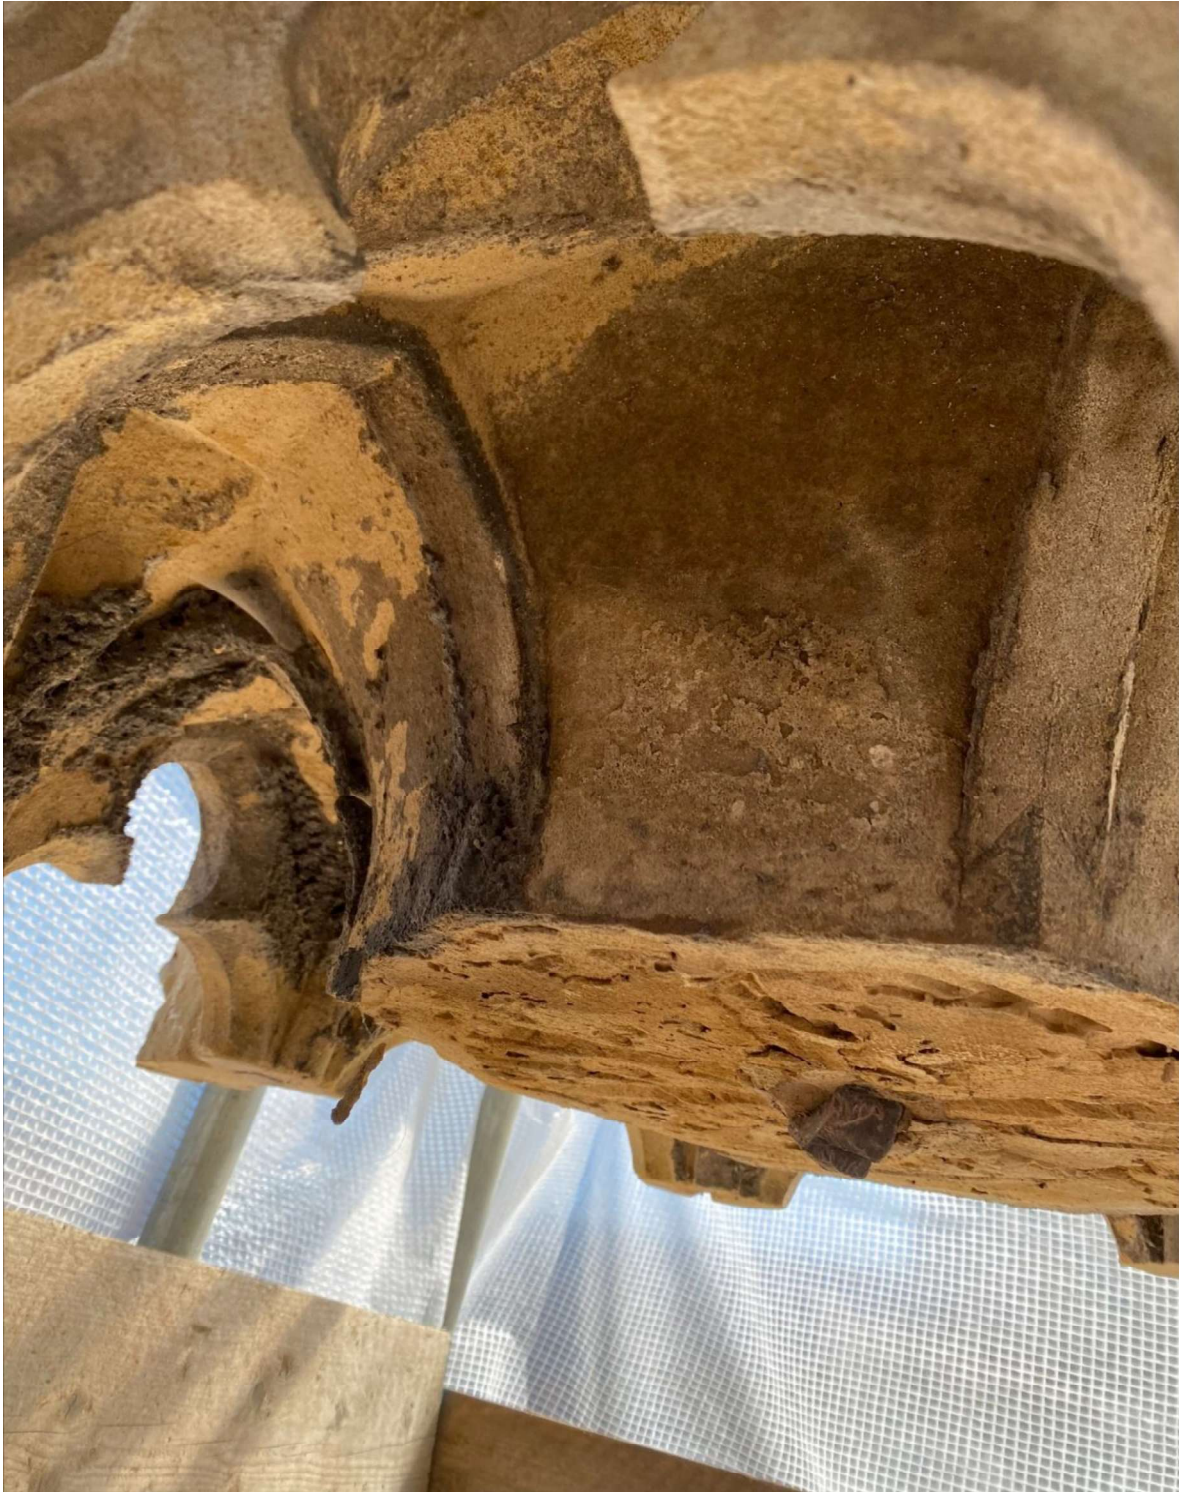
Stone number N9 after laser cleaning trials had taken place.  
A separate laser cleaning report has been prepared and submitted

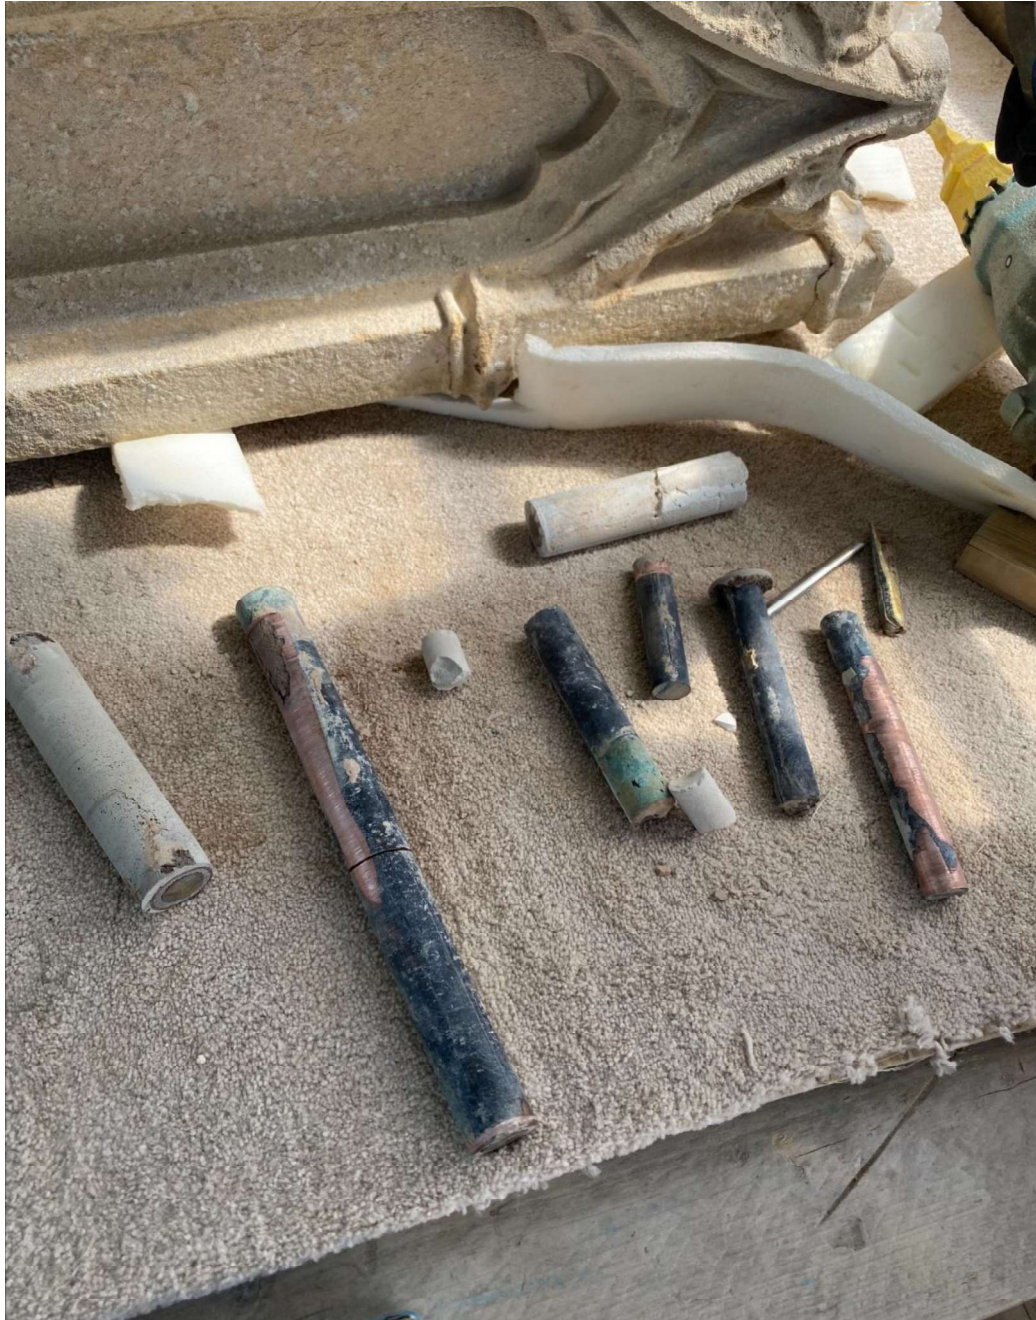
Photo showing the various different fixings found during the dismantle.  
Non ferrous metal was used for the 1990's rebuilding. Unfortunately ferrous metal embedment's were left within the structure which has caused ongoing issues further down into the heart of the structure
